MISSISSIPPI ENVIRONMENTAL GEOLOGY

David T. Dockery III and David E. Thompson

Mississippi Department of Environmental Quality
Office of Geology
Second Edition, 2019

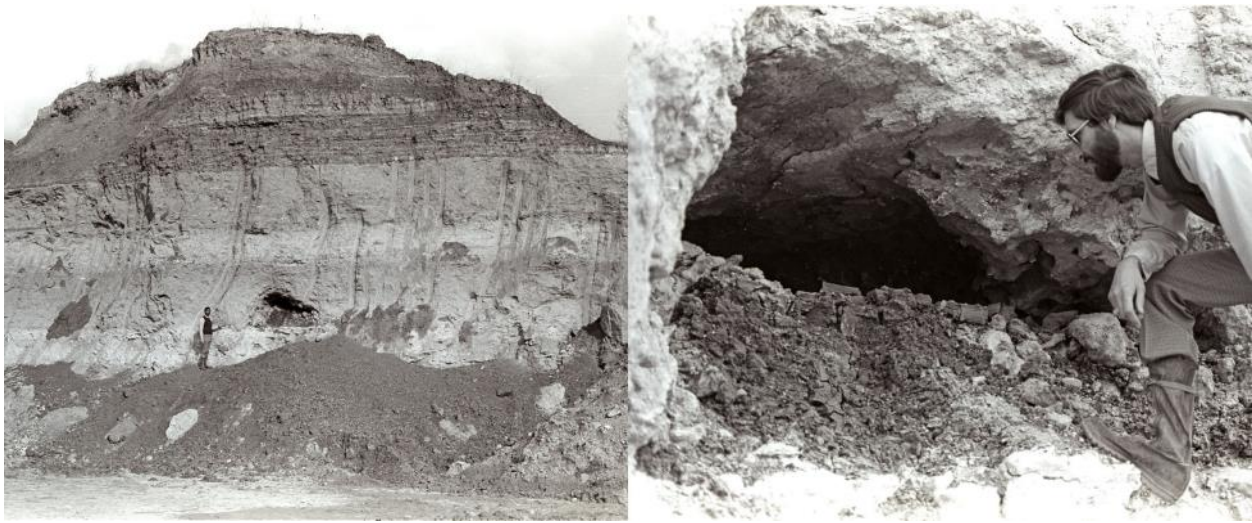
531. Left, Michael Bograd's left hand is at the Glendon Limestone-Byram Formation contact with a cave at the base of the Byram Formation to his right. Right, Michael Bograd looks into the narrow cave passage, which is half filled with Bucatanna clay from above. Pictures were taken around February of 1981.

County. Figure 4 shows a sediment-filled sinkhole in the top of the Tuscumbia Limestone in Tishomingo County (at left) and solution channels in a limestone in the Pride Mountain Formation in the same county. **Figure 529** shows sinkholes in the Clayton Formation in Tippah County. **Figure 530** shows the inside of Muddy Ridge Cave in the Clayton Formation, which is just down hill from the sinkholes in **Figure 529**. **Figure 531** shows a small cave in the high wall of the old Mar-

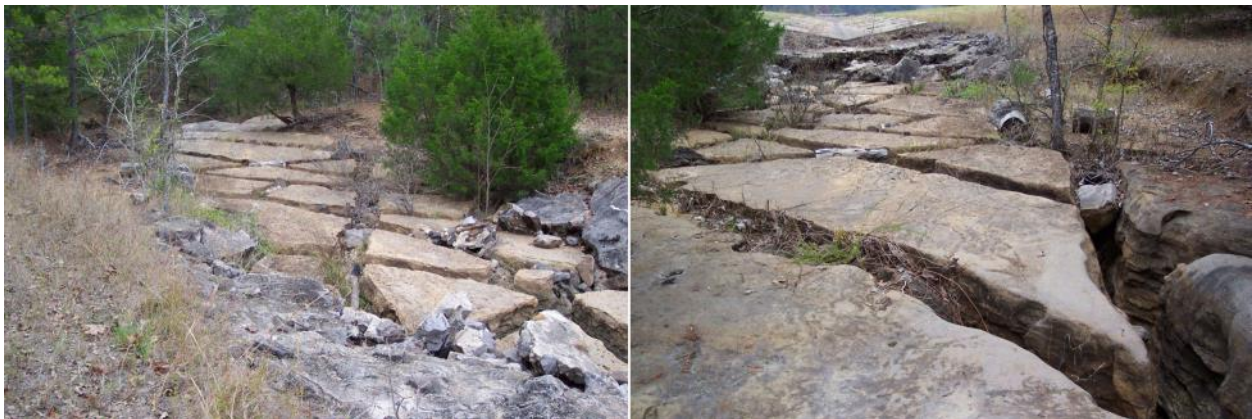
Figure 532. Left, looking down from the dam. Right, looking up toward the spillway at solution channels along joints in the basal limestone of the Green Hill Member of the Pride Mountain Formation below the spillway of Haynes Lake in Tishomingo State Park. Pictures were taken by Stephen Jennings on November 7, 2003.

joints systems (**Figure 532**). In 1980, the lake started losing water down a stump hole to such an extent that a whirlpool formed at the surface and the shoreline retreated at a rate of one foot per day. The resulting flow fed some ten to twelve springs below the dam, the largest of which had a measured flow of 200 to 300 gallons per minute (Curtis Stover, personal communication).

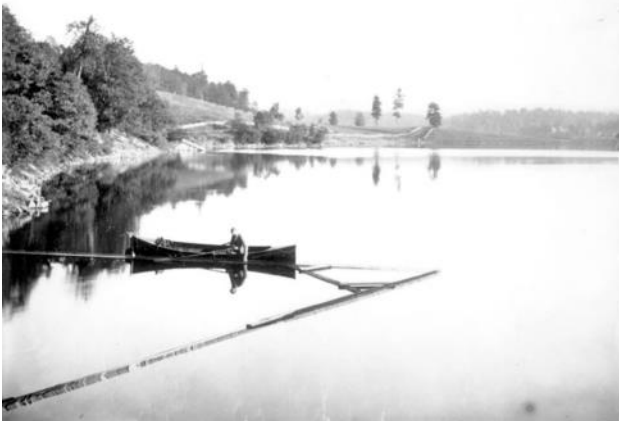
Figure 537. A canoe on Lake Conemaugh at the South Fork Fishing and Hunting Club. The fish screens are visible by the canoe; the spillway is off-camera to the left. Picture from the Johnstown Flood Museum Photo Gallery.

pense game fish, and the screen kept the fish in the lake but also collected debris (Figure 537).

The morning of May 31, 1889, the president of the South Fork Fishing and Hunting Club awoke to find the reservoir nearly cresting the dam after a night of heavy rain. In pouring rain, he quickly assembled a group of men to unclog the broken fish screen and debris from the spillway but without success. Twice telegrams were sent from the nearby town of South Fork to warn official in Johnstown that the dam was eroding. Because of similar false alerts given in past storm, the warnings were not passed on to the town authorities. Work to save the dam continued until 1:30 p.m., when the club president pull his

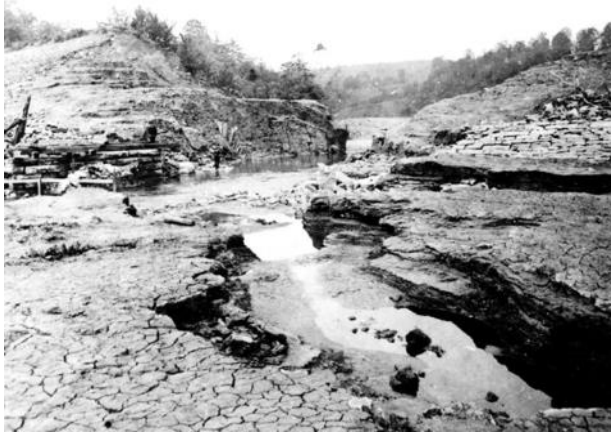
Figure 539. Dried lake-bottom mud and the breached South Fork Dam. Picture from the Johnstown Flood Museum Photo Gallery.

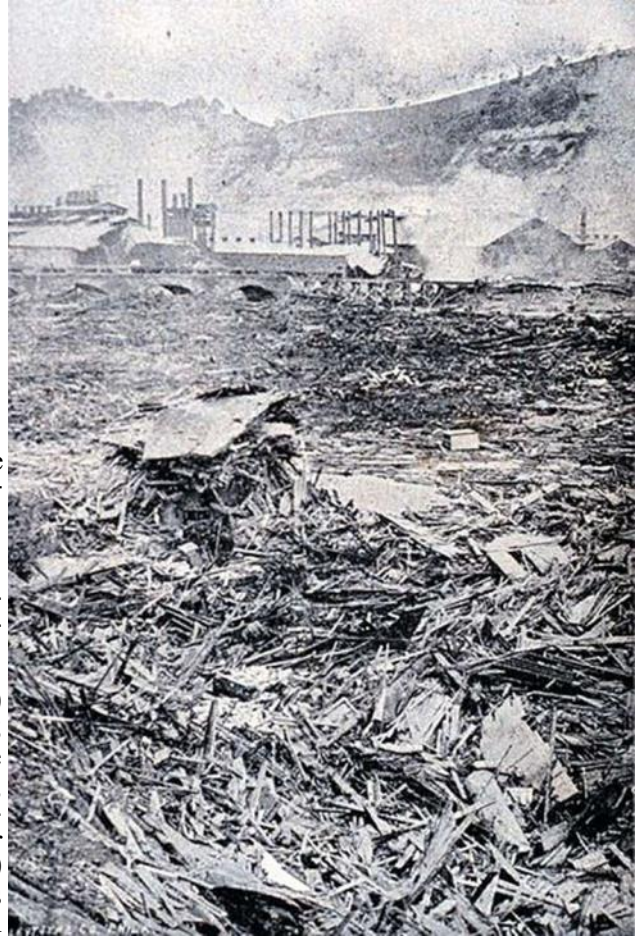
Figure 540. Debris field above Stone Bridge on the Pennsylvania Railroad (NOAA).

the Pennsylvania Railroad. The bridge held, creating a second surge that rolled upstream along the Stoney Creek River and then back again to the bridge. Debris trapped behind the bridge caught fire and burned for three days. When the flood receded, the debris field at Stone Bridge covered 30 acres and reached as high as 70 feet (**Figure 540**). In total, the flood caused \$17 million in damages and killed 2,209 people. It was the first major disaster relief led by Clara Barton and the new American Red Cross.

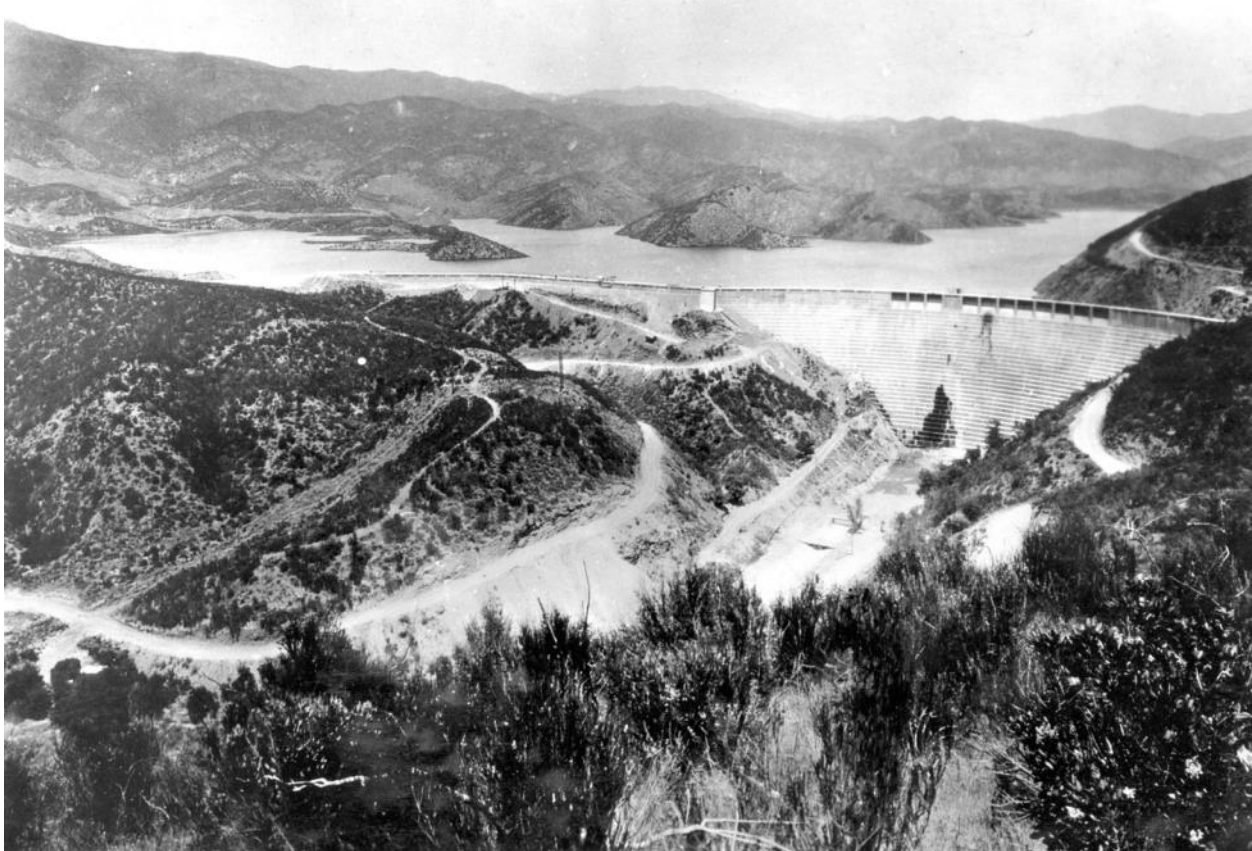
Figure 541. Photograph of St. Francis Dam before its collapse. Construction of the dam began in 1924 and finished in 1926. The dam failed right before midnight on March 12, 1928. The photograph is from the Los Angeles Bureau of Power and Light as contained in the U.S. Geological Survey Photographic Library.

reservoir, causing temperature-related contraction crack in the dam and minor seepage under the abutments. In April the water level reached the inactive San Francisquito Fault line, and the dam began to leak at that point immediately. Worker were only partly successful in sealing the leak. Drainage pipes under the dam carried away water to relieve the hydrostatic pressure at the base of the dam and, thus, to prevent lift. Water from the dam was used to supply the Los Angeles Aqueduct after sections of the aqueduct in Owens Valley were dynamited in May 27; between 7,000 and 8,000 acre-feet were diverted. On March 7, 1928, the lake level was three inches below the spillway and no more water was turned into the reservoir (**Figure 541**).

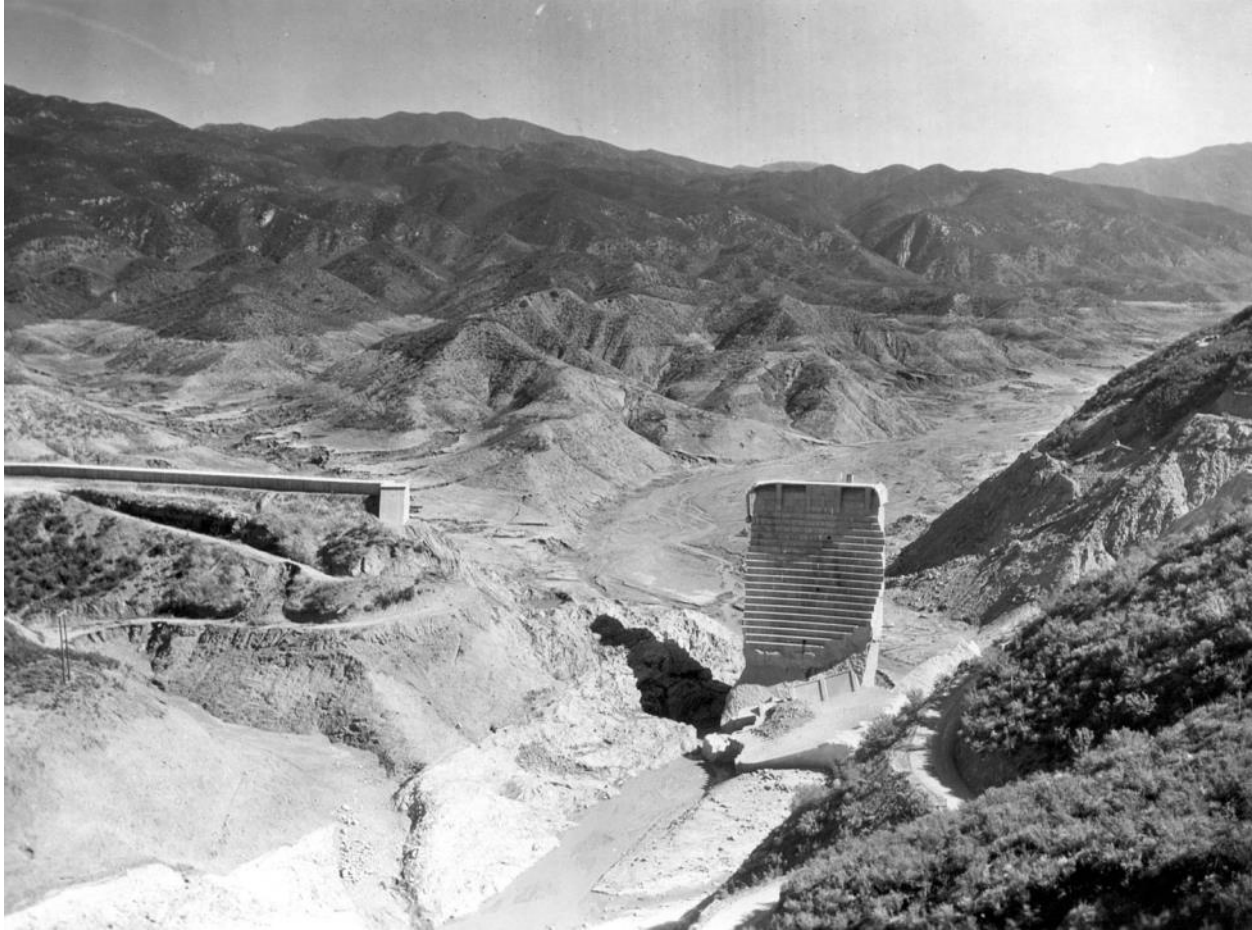
Figure 542. After the St. Francis Dam failure, only the middle section of the dam, a section known as the "Tomb Stone," was left standing. The contact of the Pelona Schist and Vasquez conglomerate, the location of the inactive San Francisquito Fault, is visible to the left of the dam remnant. Picture was taken on March 17, 1928 (U.S. Geological Survey Photographic Library).

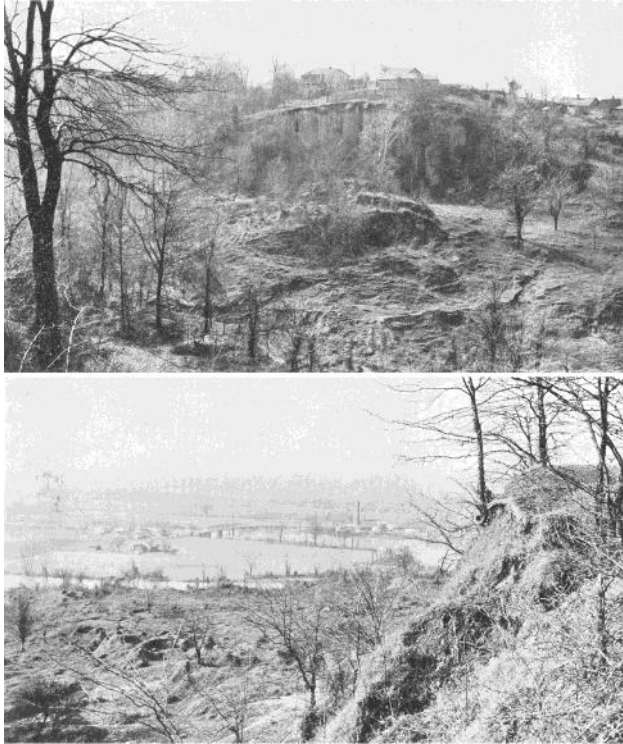
Figure 546. Top, landslide that extended to the top of the first spur ridge (A) east of the Yazoo River. Bottom, the landslide embraced the whole vertical face of the east bluff of the Yazoo Valley on the west side of the first spur ridge (A); the camera is pointed North 22 degrees West toward the proposed bridge site. Pictures are from figures 5 (top) and 7 (bottom) of Mississippi Geological Survey Bulletin 27 (Morse, 1935).

bridge site (**figures 546-547**) and steered the Highway Department to a better location labeled E-F in Figure 4, which is the location of the bridge today. In Mississippi Geological Survey Bulletin 27 entitled "Geologic Conditions Governing Sites of Bridges and Other Structures," Morse said (Introduction, page 7) that his condemnation of the site saved the state perhaps \$100,000 (\$250,000 if the cost of the whole bridge project is included), an amount equivalent to the State Geological Survey's appropriation in 15 years.

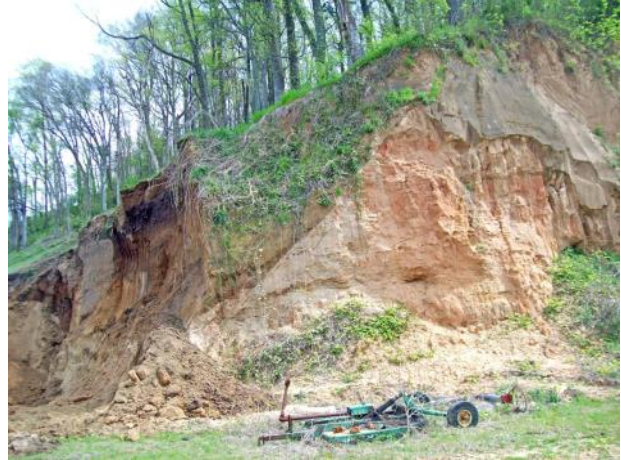
Figure 548. Landslide scarp of loess at left against pre-loess sand and gravel at right along the bluff line on Old Highway 61 in Vicksburg, Mississippi. Picture was taken by James Starnes on April 8, 2013.

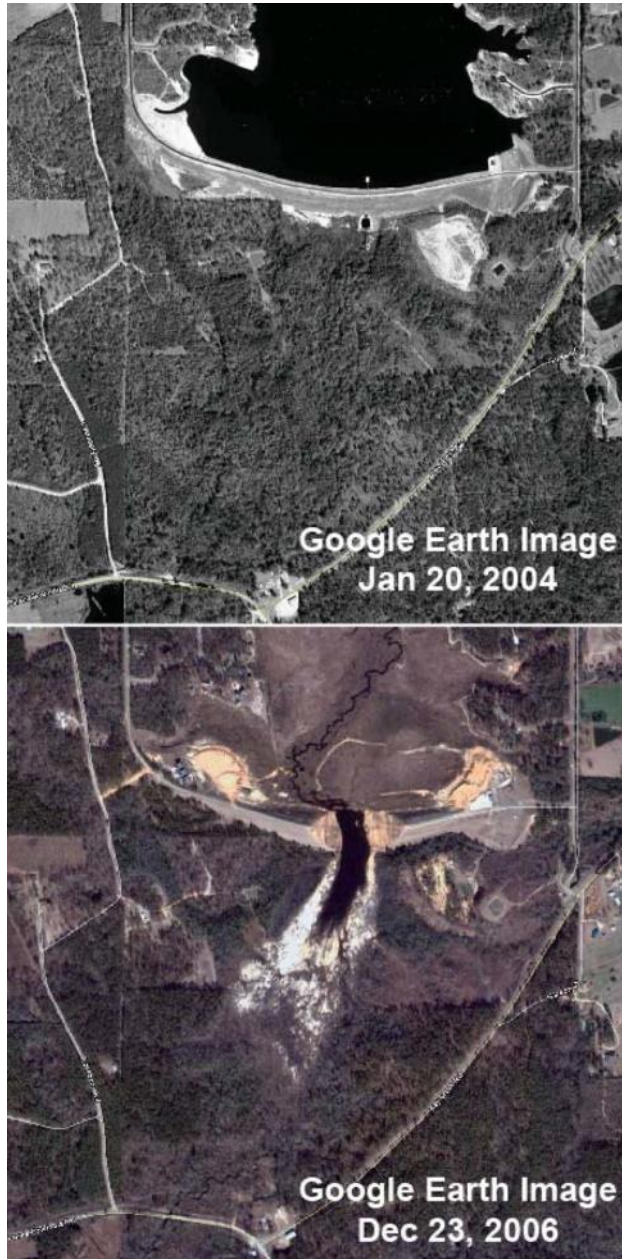
Figure 550. Satellite images of the Big Bay Dam before (top), and after (bottom) the failure. The scar left by the flood waters is clearly visible in the image below (from Altinakar, et al., 2010). Image 2398.

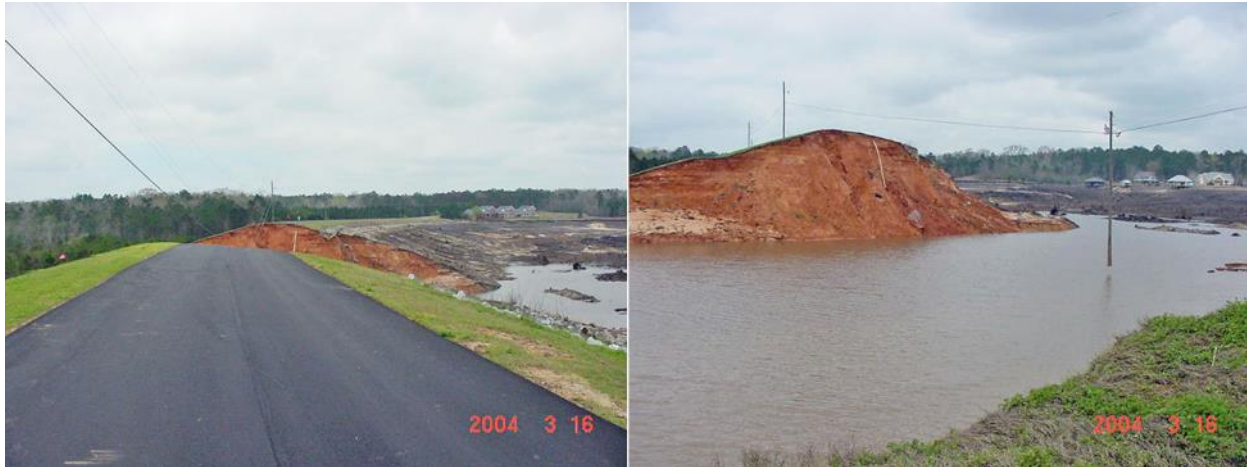
Figure 551. Failure breach in the Big Bay Dam. Pictures were taken by the National Weather Service Forecast Office in Jackson, Mississippi, on March 16, 2014. Image 2399.

Falls Dam failure in Georgia, (6) the 2003 Silver Lake Dam failure in Michigan, and (7) the 2004 Big Bay Lake Dam failure in Mississippi. According to Baker and Graham (2008, p. 10) the Big Bay Lake Dam failure was one of the largest volumes of water (22,100 acre-feet) released from a U.S. dam failure.

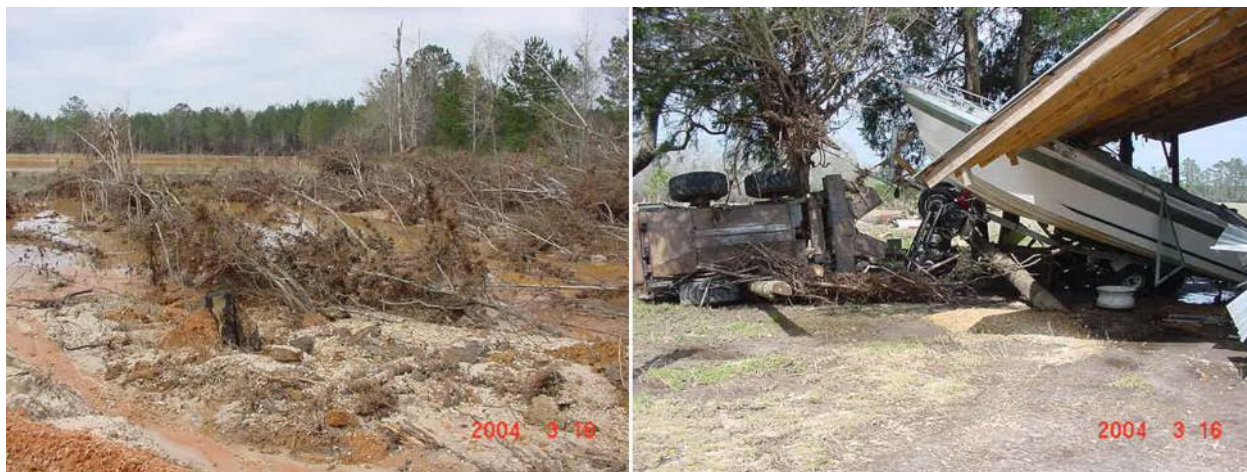
Figure 552. Damage caused the Big Bay Dam failure flood surge. Pictures were taken by the National Weather Service Forecast Office in Jackson, Mississippi, on March 16, 2014. Image 2400.

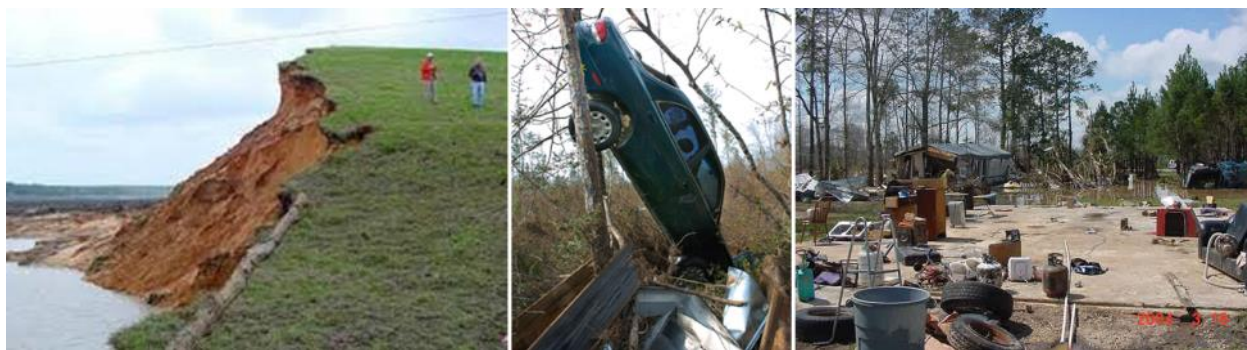
Figure 553. Left, Breached dam. Center, car washed into a tree. Right, Slab foundation of a home washed into the tree line. Pictures were taken on March 16, 2004. Image 2401.

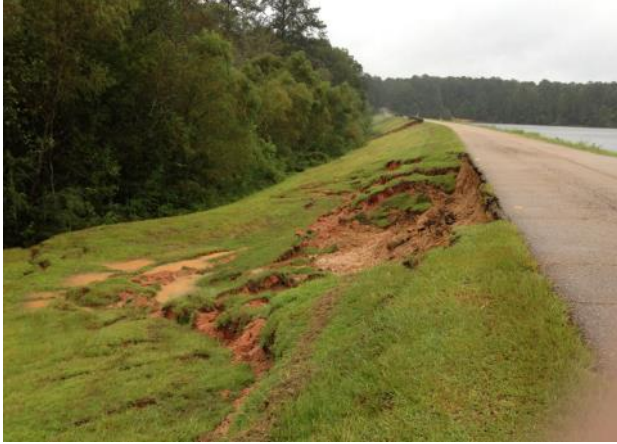
Figure 556. One of two slope failures on the Lake Tangipahoa Dam. Water seeping over the dam's clay core can be seen at lower left. Picture was taken by Mike Meadows on August 30, 2012 at 9:19 a.m. Image 2404.

Lake Tangipahoa was scheduled to be drained and the dam rebuilt before Hurricane Isaac. The dam was dilapidated and not condition to withstand a large rain event. Before Isaac made landfall, MDEQ geologist and dam safety engineer Mike Meadows called several dam sites of large reservoirs with the message to monitor the dam and call him if a problem developed. At about 6:45 a.m. on August 30, a call came in from Percy Quinn State Park — we have a problem. The park ranger had spotted a 70-foot wide landslide on Lake Tangipahoa's dam (**Figure 556**). The ranger then notified the local emergency manager and the National Weather Service.

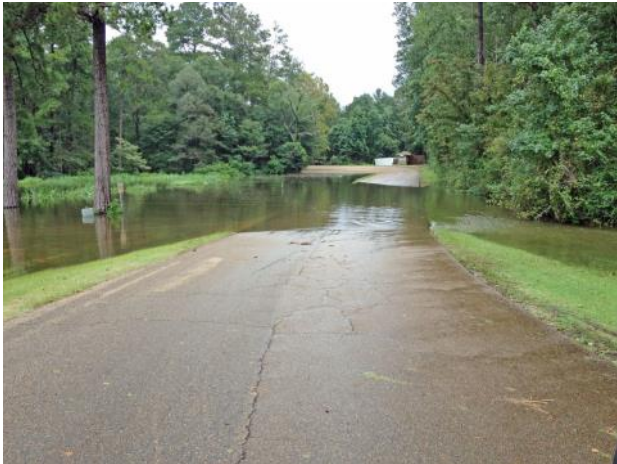
Figure 558. Flood waters flow over low spot on park road to Lake Tangipahoa Dam. Picture was taken by Mike Meadows on August 30, 2012, at 2:56 p.m. Image 2406.

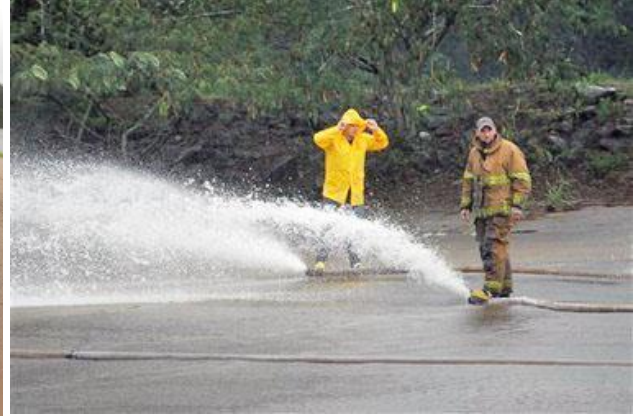
Figure 557. Firefighters pump water out of Lake Tangipahoa in an effort to relieve pressure on the dam. Picture was taken on August 30, 2012 (AP Photo/The Enterprise-Journal, Matt Williamson, published on August 31, 2012). Image 2405.

on August 30 (**figures 557-559**). Louisiana National Guard helicopters placed boulders on the dam to ensure against failure, and the Mississippi National Guard arrived on site with bulldozers and trackhoes. The plan was to remove some of the roadway on the dam and allow some of the high water to flow into the fields, lowering the threat. The Nation Guard's equipment was relatively new but had seen little service. When put into operation, hydraulic lines on the heavy machinery gave way, each of which required a specified part. Soon well-used MDOT equipment and personnel took over the construction site.

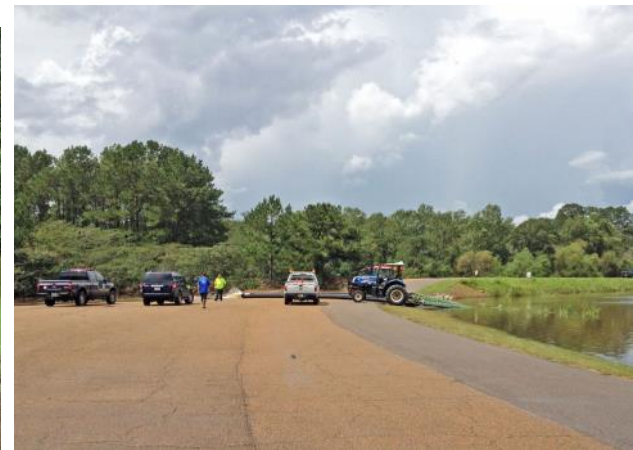
Figure 559. Tractors pump water from Lake Tangipahoa to lower the lake level against a backdrop of storm clouds in the distance. Picture was taken by Mike Meadows on August 31, 2012, at 12:01 p.m. Image 2407.

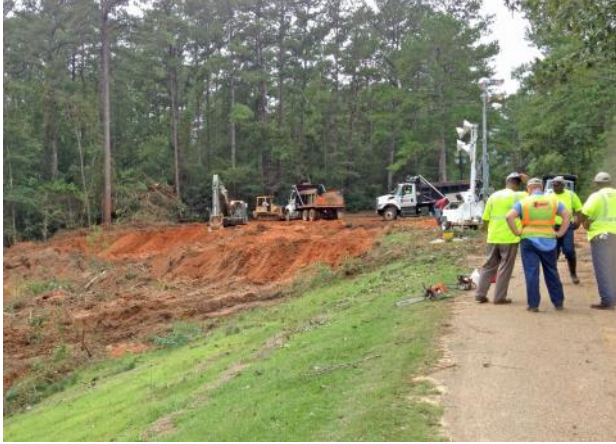
Figure 560. Green National Guard trackhoe at left and MDOT bulldozer, dump trucks, and personnel make the initial clearing and excavation to divert the lake water around the dam. Picture was taken by Mike Meadows on August 31, 2012, at 1:30 p.m. Image 2408.

combat engineer unit (**Figure 560**) was dispatched to clear a forest and dig down through 30 feet of a hillside to excavate a 600-foot-long channel as a diversion around the dam for the flood waters. As mentioned before, this work was taken over by MDOT (**Figure 562-562**). When dam engineers decided to drop the water level in the lake at least eight feet to take pressure off the dam, the US Army Corps of Engineers brought in huge pumps capable of pumping 140,000 gallons a minute and dropping the lake level about a foot a day (**Figure 563**). Equipment and personnel from the Mississippi Department of Transportation took over the earthmoving job in the construction of the diversion canal (**Figure 564**) and worked through the night to complete the job.

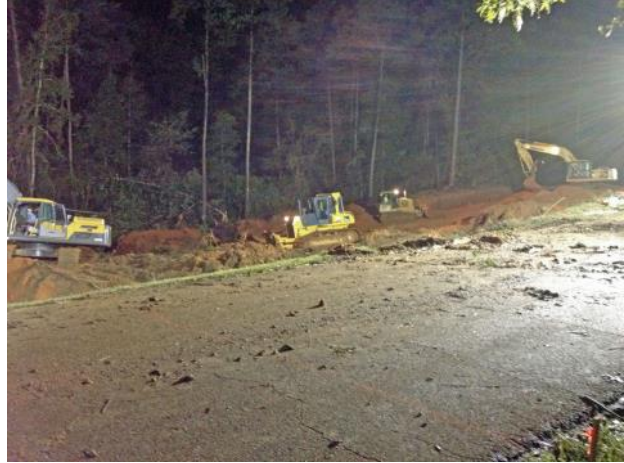
Figure 561. MDOT crew and equipment work through the night on excavating the diversion canal. Picture was taken by Mike Meadows on August 31, 2012, at 8:37 p.m. Image 2409.

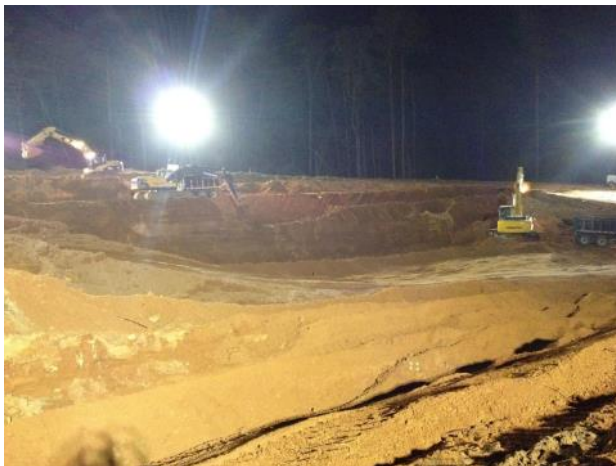
Figure 562. The diversion canal deepens as MDOT crews continue work around the clock. Picture was taken by Mike Meadows on September 5, 2012, at 9:13 p.m. Image 2411.

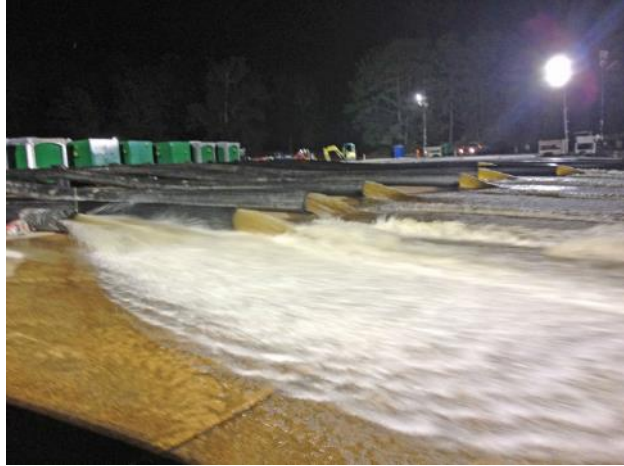
Figure 563. US Army Corps of Engineers 140,000-gallon-per-minute pumps lower the lake level. Picture was taken by Mike Meadows on September 5, 2012, at 9:05 p.m. Image 2410.

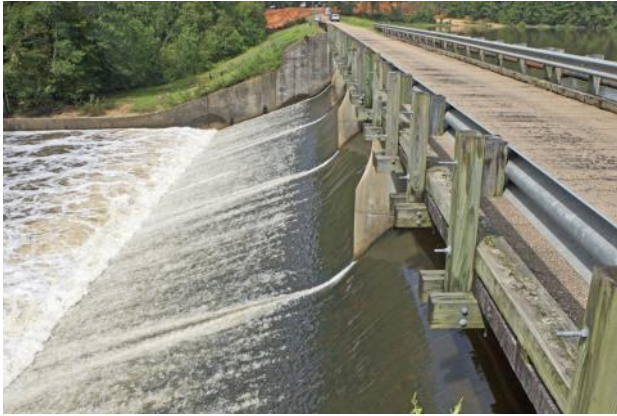
Figure 564. Overflow at Lake Tangipahoa spillway on September 1, 2012. Excavation of diversion canal can be seen above the spillway road. Picture was taken by Mike Meadows. Image 2412.

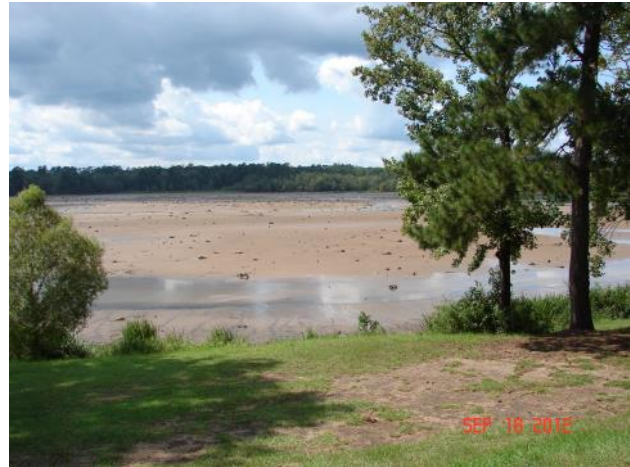
Figure 565. The drained bottom of Tangipahoa Lake. Picture was taken by Mike Meadows on September 18, 2012. Image 2413.

of Lake Tangipahoa was near completion (**Figure 565**), the body of a missing 18-year-old girl, Leslie Allen of McComb, was found on the lake bottom. Allen had been missing since September 4, and an autopsy showed no obvious signs of trauma. **Figures 566-567** show the failed dam slope, which consisted of unconsolidated sand and gravel. **Figures 568-569** show the diversion canal, with emptied into an older canal created for a pervious dam repair (**Figure 570**).

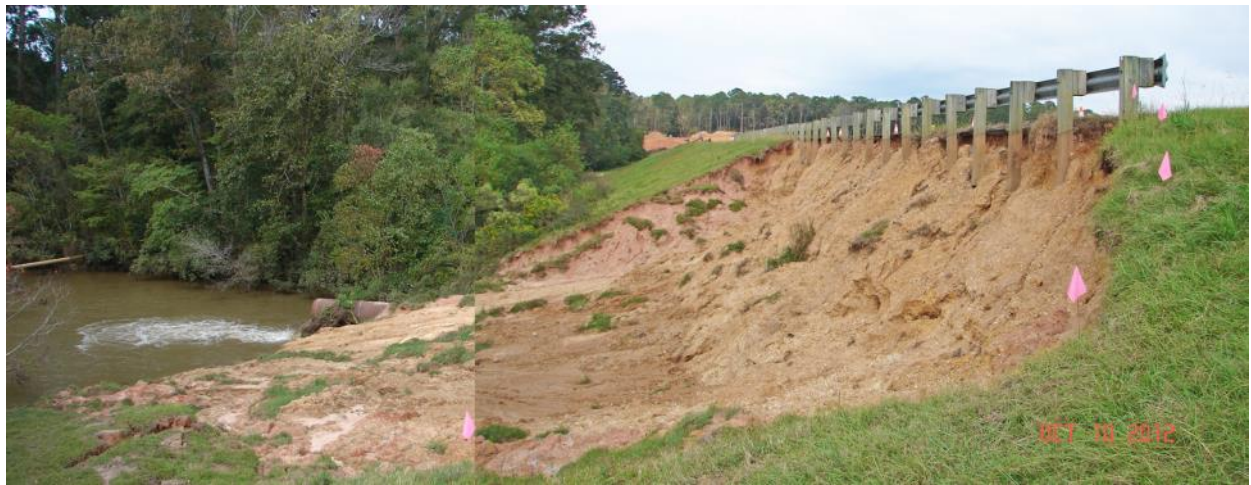
Figure 566. Composite image of the dam landslide. The darker area in the middle of the slide is a seepage site from water moving over the dam's clay core. Picture was taken by Mike Meadows on September 18, 2012. Image 2414.

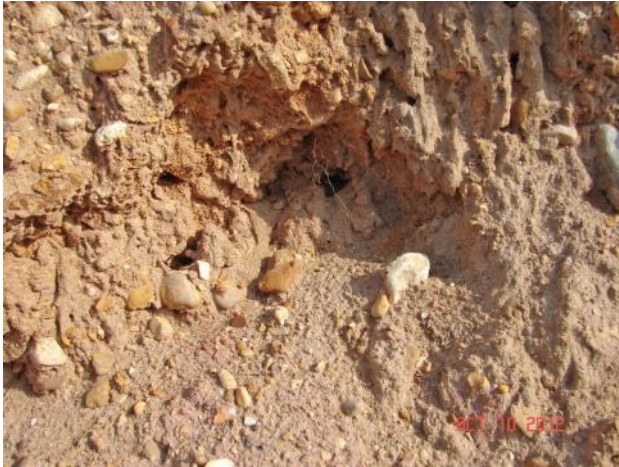
Figure 567. Seepage site at dam landslide. The sand and gravel slope on both sides of the dam's clay core is fill from the Citronelle Formation, which covers nearly the whole surface of Pike County. Picture was taken by Mike Meadow on October 10, 2012. Image 2415.

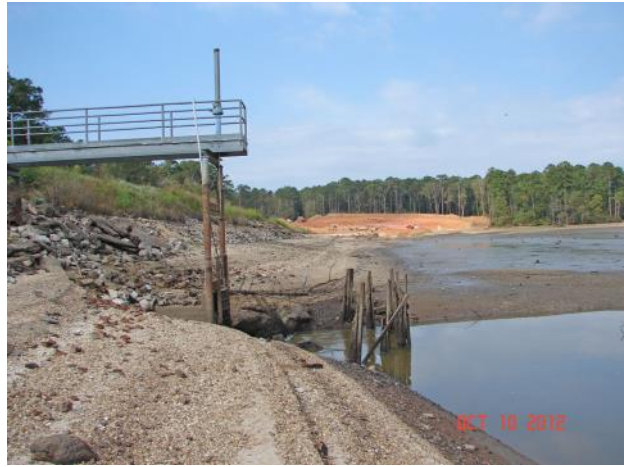
Figure 568. Tangipahoa Lake's drain (Figure 520 shows other end of drain) stands high above the water in the nearly-drained lake. Behind it in the distance is the excavation of the diversion canal. Picture was taken by Mike Meadows on October 10, 2012. Image 2416.

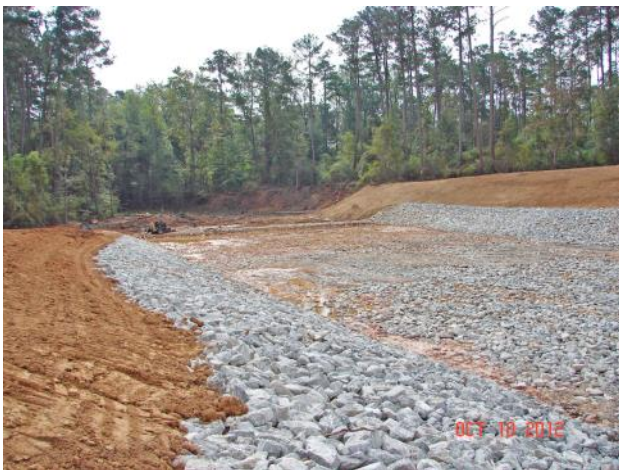
Figure 569. A rip-rap on fabric lining was installed on the diversion canal to prevent soft sands of the Citronelle Formation from eroding. Picture was taken by Mike Meadow on October 10, 2012. Image 2417.

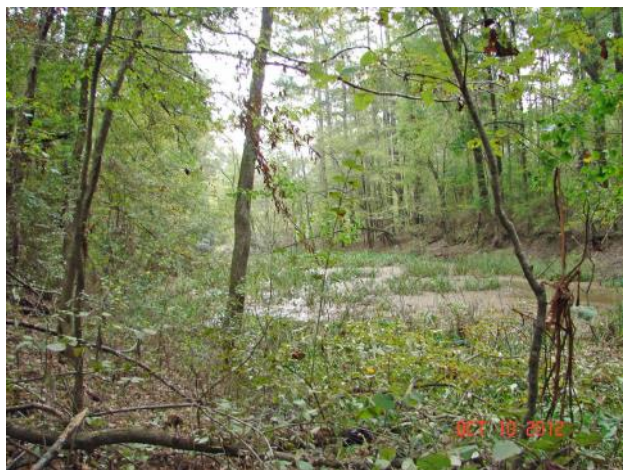
Figure 570. The end of the diversion canal led to an old canal used as a diversion from a previous lake repair. Picture was taken by Mike Meadows on October 10, 2012. Image 2418.

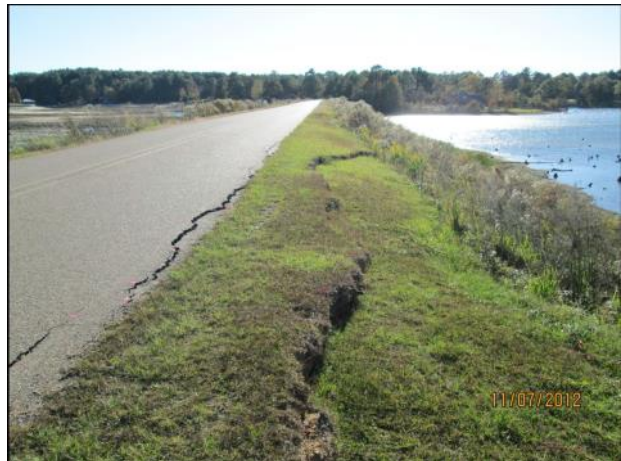
Figure 574. Slope failure on Lake Serene slope and road, from Walker Associates in a Presentation to Homeowners Association. Image 2421.

Lake Serene #6 Dam was built in 1969 at a length of 1,912 feet and a height of 24 feet with a normal lake surface area of 68.5 acres. The lower level outlet consisted of a 24-inch-diameter metal pipe. The principal spillway was 50 feet in width; there was no emergency spillway. The dam's hazard classification was High.

The estimated cost near the time of final construction plans was placed at \$1,65 million and required an assessment of \$2,921. Repair of the dam's downstream slope required benching of fill, beginning at the base of the dam and creating a terraced appearance as the work continued toward the top (Doherty, Hattiesburg American, 2014).

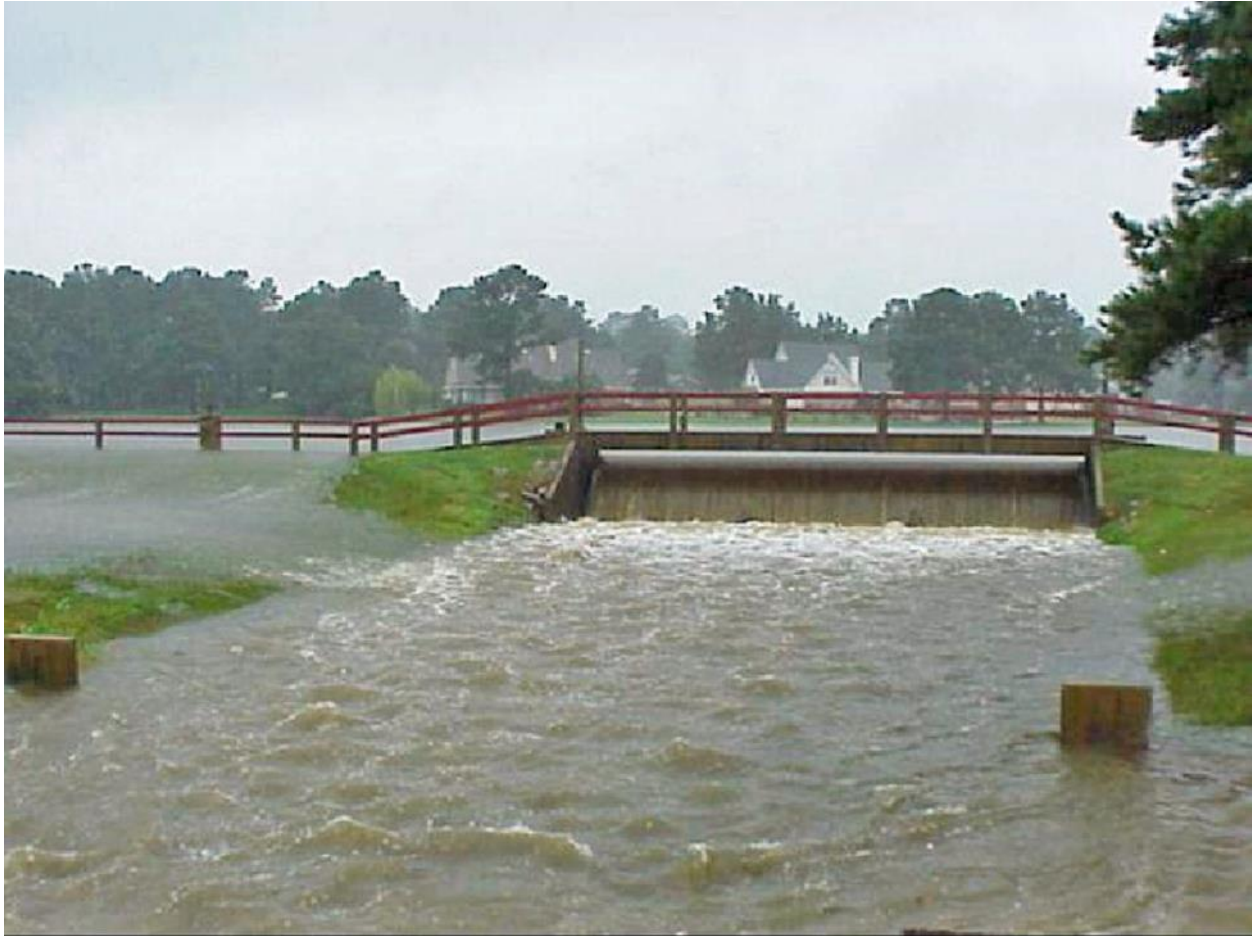
Figure 575. Water overtopping dam in Rankin County during storm event that was greater than the spillway design. Image 2422.

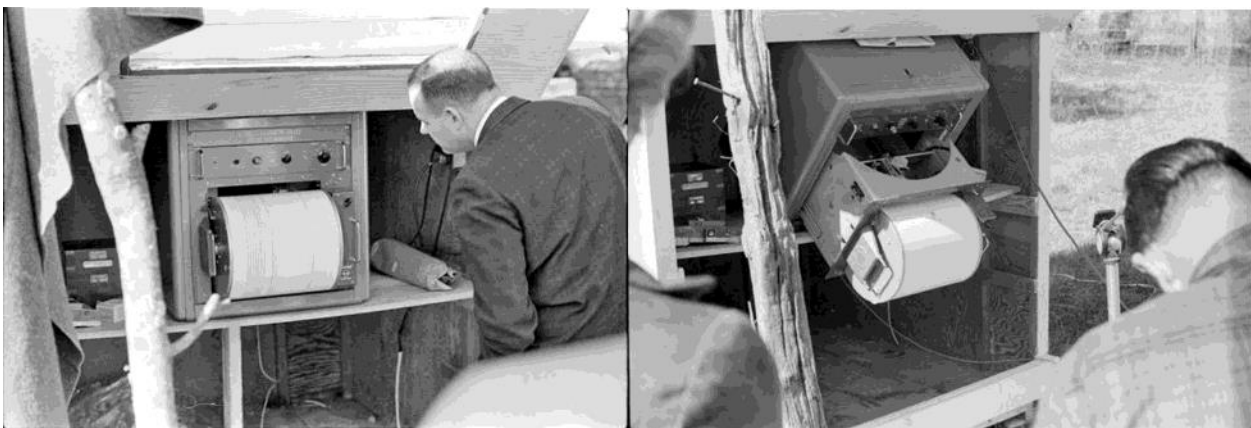
Figure 582. Seismograph before blast (left) and toppled after blast (right) at Tatum Salt Dome nuclear test site official observation point, respectively, before and after 10:00 a.m. on October 22, 1964. Items #240 (left) and #250 (right) of the MDAH Moncrief Photograph Collection. Image 2428.

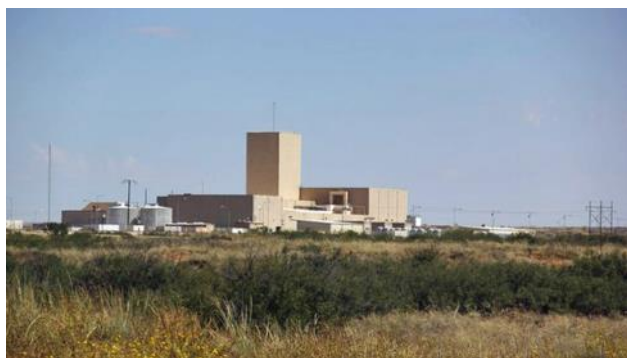
Figure 590. Waste Isolation Pilot Plant (WIPP) in Carlsbad, New Mexico, is the only long-term geologic repository for nuclear waste in the United States (Wikipedia).

Today the only long-term geologic repository for nuclear waste is the Waste Isolation Pilot Plant in Carlsbad, New Mexico (**Figure 590-593**). The plant is the world's third deep geological repository licensed to permanently dispose of transuranic radioactive waste produced at government research and nuclear weapons facilities (Figure 540) for 10,000 years. The repository is in 3,000-foot-thick bedded Permian salt (Salado and Castile formations) 2,150 feet below ground level and 1,000 feet above sea level and is located in the Delaware Basin in Eddy County, New Mexico (**Figure 591**).

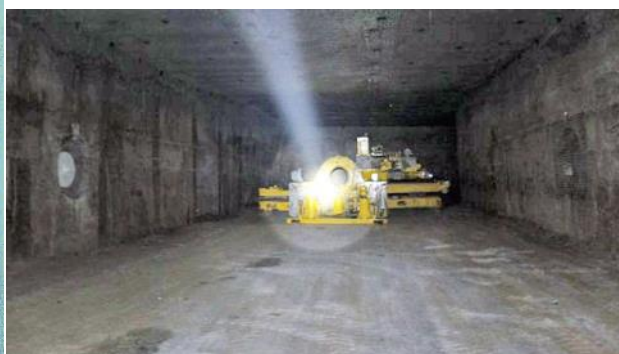
Figure 593. WIPP's Room 7 in Panel 7, empty in October 2013, where airborne radiation was first detected underground, on February 14, 2014. More tests confirmed the presence of radioisotopes of americium and plutonium in above-ground air filters.

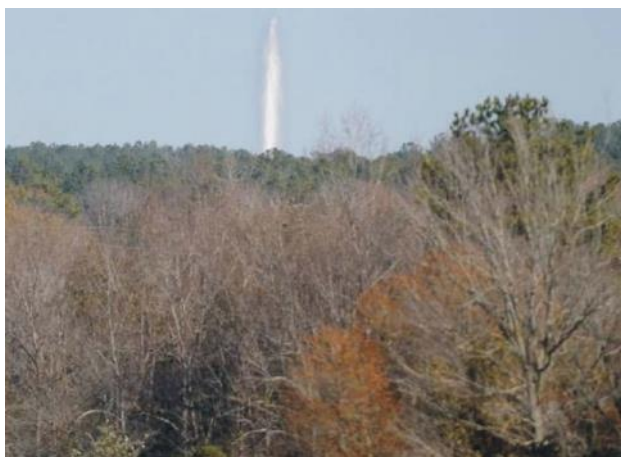
Figure 600. A 300-foot-high water geyser vents from a water well at the Eminence Gas Storage facility in Covington County near the Jones County line. An underground storage cavern was discovered to be leaking around 8 p.m. on Monday, December 31, 2010 (Matt Bush/Hattiesburg American). Image 2527.

The initial December 26, 2010, gas leak from Cavern 3 sent water shooting into the air from on-site water wells. In one well, the pump blew out of the ground, and water shot 300 feet into the air (**Figure 600**). Another interesting phenomena on adjacent property was the flowage of a "mud volcano" from what appeared to be an old seismic test hole plugged with a wadded up milk cartoon (**figures 601-603**). The mud flow was investigated after the fact by James Starnes and John Marble of MDEQ's Office of Geology on January 5, 2011.

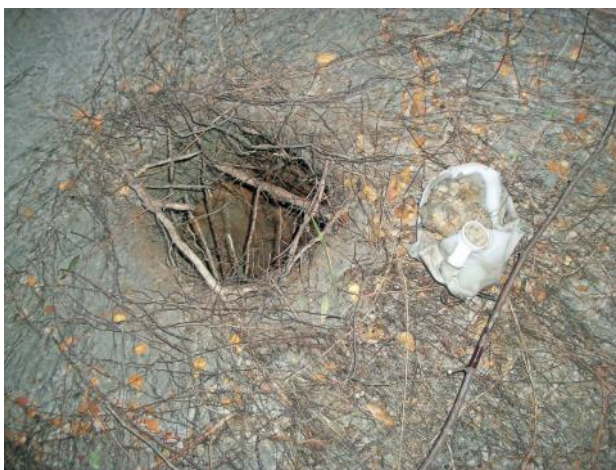
Figure 601. "Mud volcano" vented from an old seismic test hole in Covington County near the Eminence Gas Storage facility. The crumpled plastic milk jug is believed to be the object used to plug the hole. Picture was taken by James Starnes on January 5, 2011. Image 2528.

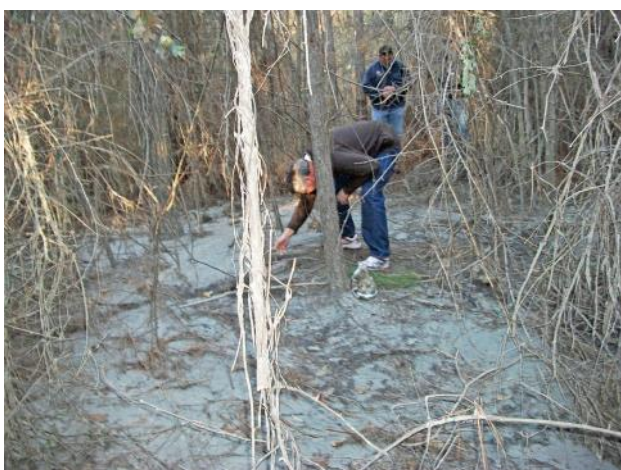
Figure 602. Blue-gray silty mud sprayed on tree tops from a geyser and mud flow that filled a cow pond downhill and overflowed the pond to enter a nearby creek. Picture was taken by James Starnes on January 5, 2011. Image 2529.

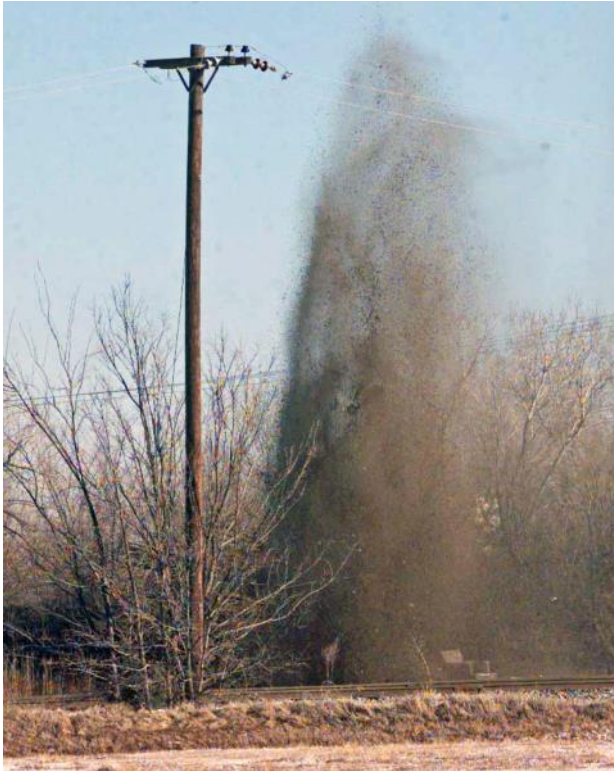
Figure 607. Thirty-foot geyser of natural gas, dirt, and brine from an abandoned brine well northwest of the Big Chief Mobile Home Park in Hutchinson, Kansas, where a mobile home exploded on January 18, 2001, killing two people (from the Kansas Geological Survey). Image 2504.

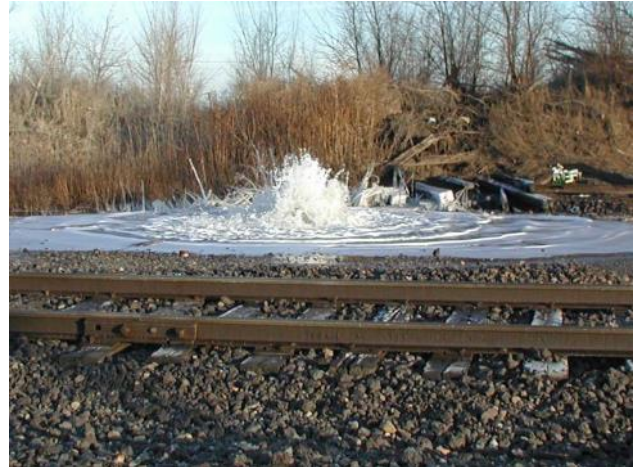
Figure 608. Small geyser of gas and brine near a railroad track in eastern Hutchinson, Kansas (from the Kansas Geological Survey). Image 2505

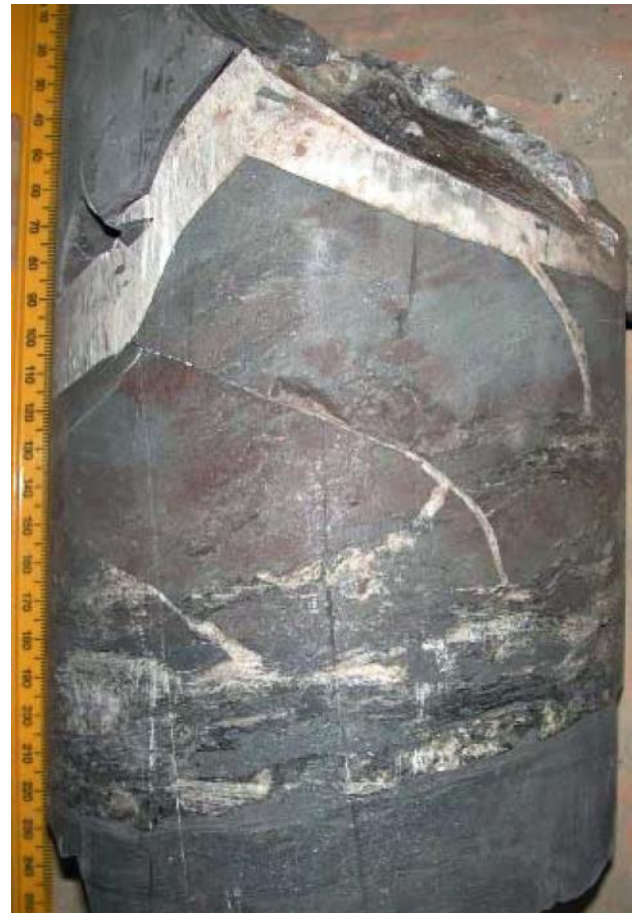
Figure 609. Core of the lower Ninnescah Shale with gypsum-filled fractures that served as a seal for rising natural gas from the leaking pipe in the S-1 jug. Core is from a well drilled close to the many geysers on the east side of Hutchinson, Kansas (from the Kansas Geological Survey). Image 2506.

Gas from the leaking casing moved up hole until it reached an impenetrable gypsiferous zone at the base of the overlying Ninnescah Shale (**Figure 609**). It then moved updip along the Upper Wellington Shale-Ninnescah Shale boundary until it encountered the bore holes of abandoned brine wells, through which the gas vented to the surface with explosive results (**Figure 610**). One such well was discovered in the basement of one of the stores destroyed in downtown Hutchinson. It had been drilled to provide brine waters for a hotel spa. Geologists with the Kansas Geological Survey mapped the top of the Wellington Formation and found an anticlinal structure beneath the city into which the gas had accumulated (**Figure 611**).

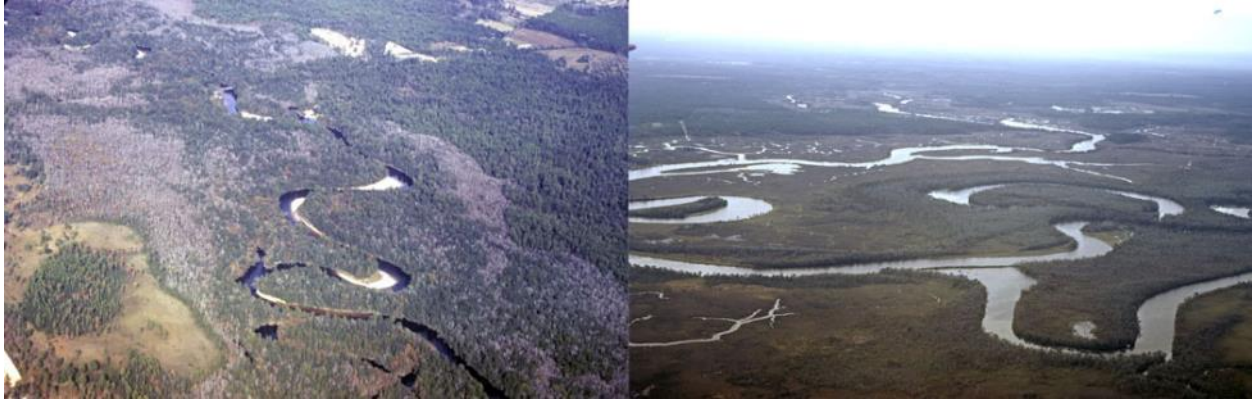
Figure 613. At left, the meander belt of the Pascagoula River in northern Jackson County, Mississippi. At right, Mississippi coastal marshes along the Pascagoula River in Jackson County. Pictures taken in November of 1973. Image 1841.

graduate students and the Ole Miss airplane before the flyover. **Figure 613** shows the meander belt of the Pascagoula River and the river's upper estuary. **Figure 614** shows the lower estuary of the Pascagoula within view of the coastline. **Figure 615** shows the mouth of the Pascagoula River and the beach and sand shoals at Belle Fontaine Point. **Figure 616** shows the salt-water marsh behind the beach at Belle Fontaine Point and an eroded beach nearby. **Figure 617** is the *Environmental Geologic Map, Jackson County, Mississippi*. A digital copy of this map was made available to us by Charles Swann of the Mississippi Mineral Resources Institute at the University of Mississippi.
